Plum Brook Reactor Facility

NASA Glenn Research Center Plum Brook Reactor Facility Decommissioning Overview

Rod Case - Decommissioning Project, Asst. RSO

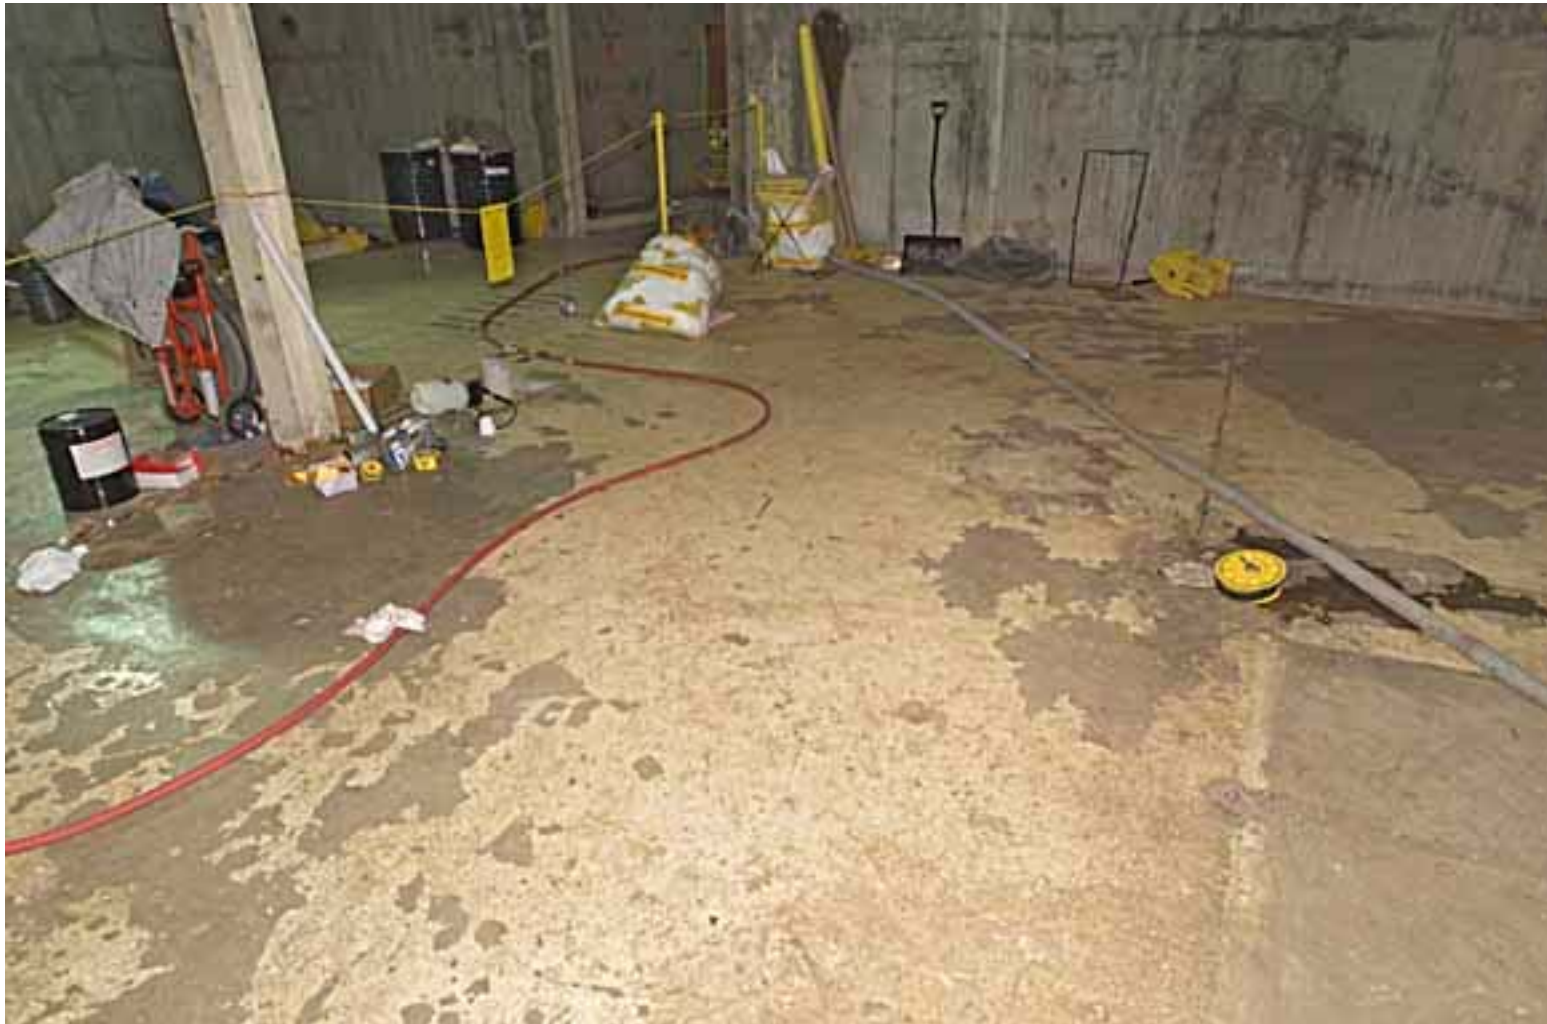
Hot Pipe Tunnel - Before

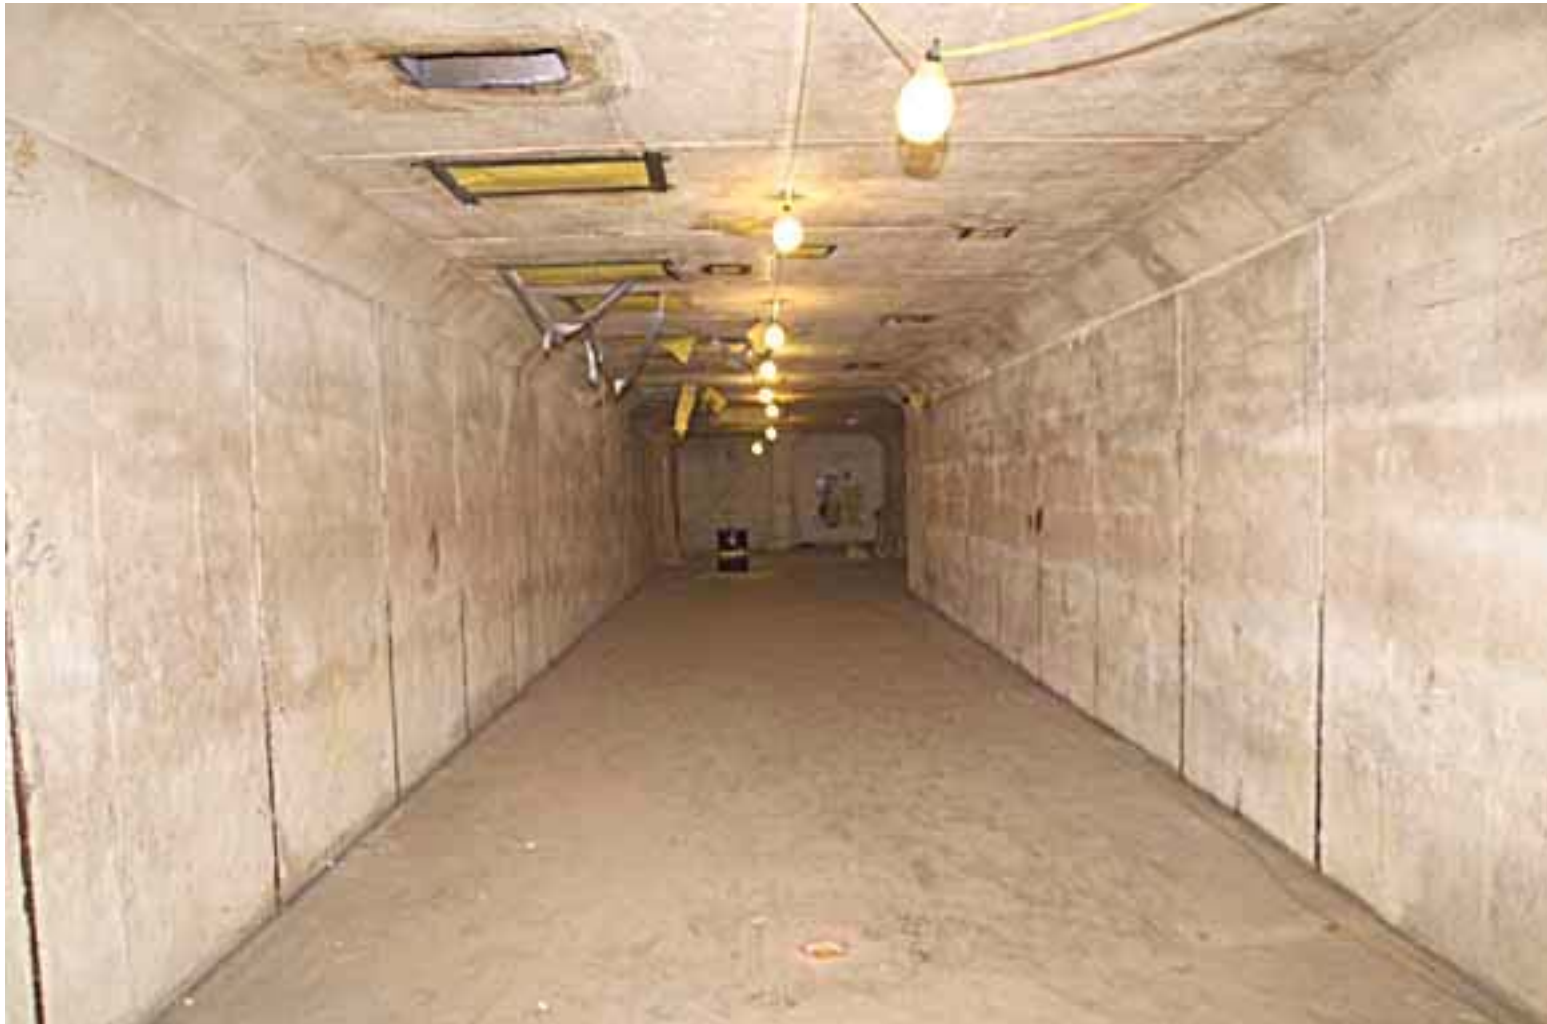
Hot Pipe Tunnel Roof and wall - after

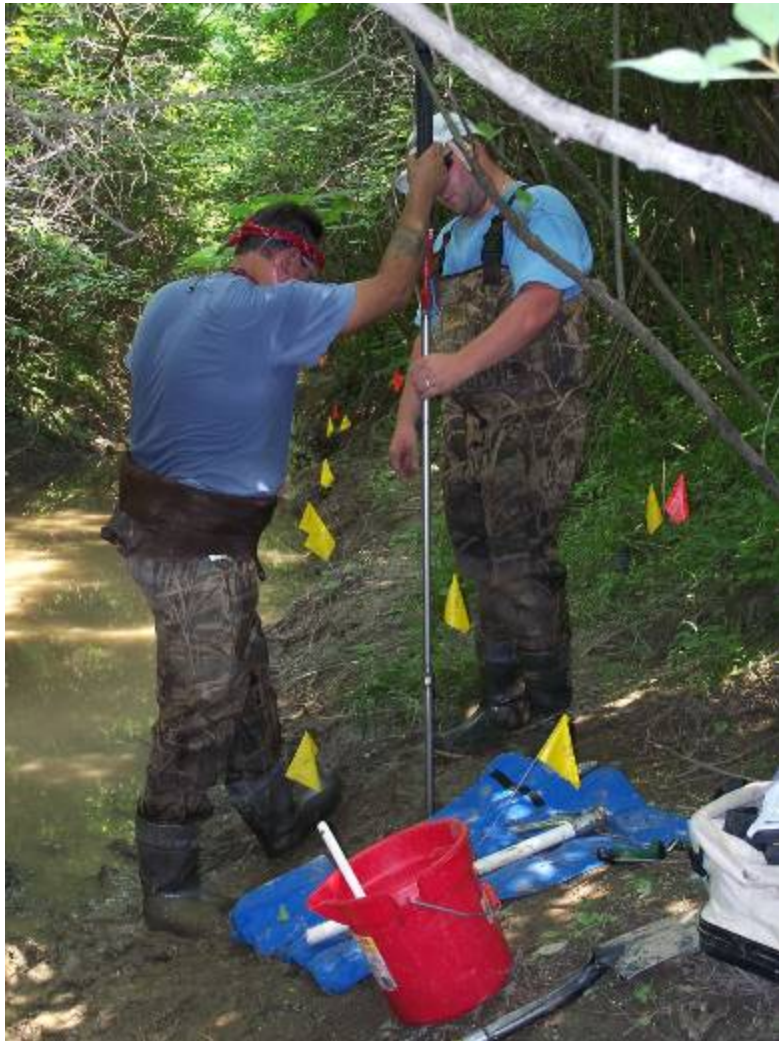
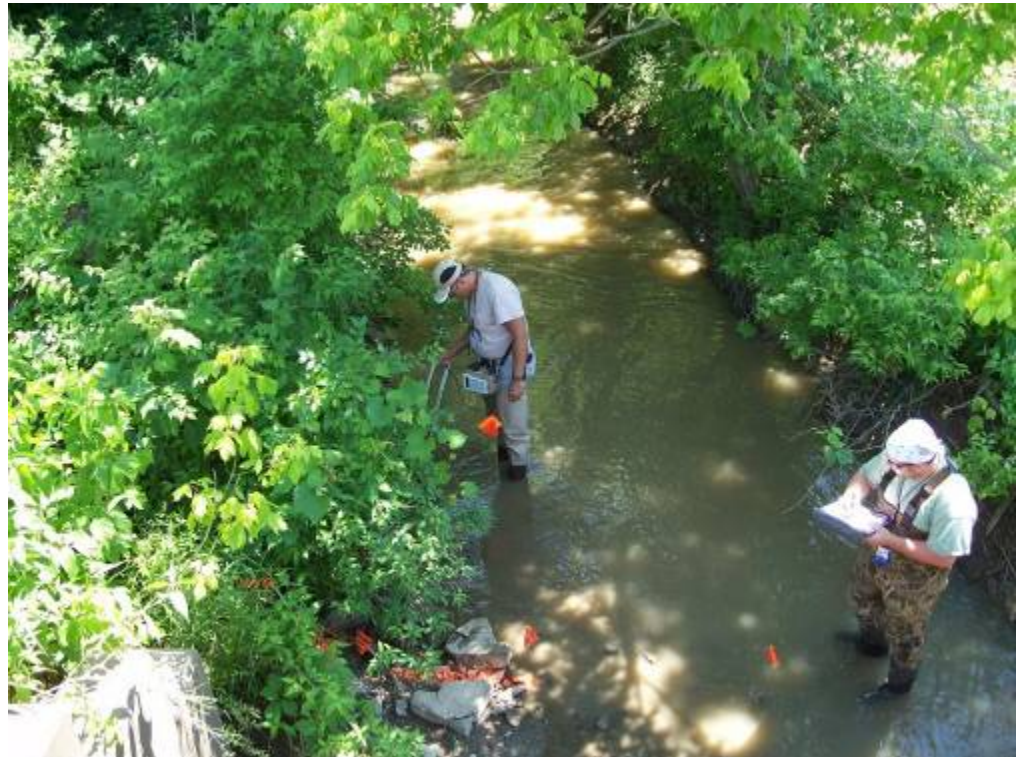
Plum Brook Characterization and Modeling

- With guidance from Haag Environmental Company, a local company with hydrogeologic expertise, we understand what happened to the cesium-137 that was discharged from the facility during operation
 - How the material moved downstream over time
 - Where it is now
- Cesium binds almost permanently with clay sediment
 - Find where the sediment moved to, you find the cesium
- Deposits, or cells, tend to be isolated, relatively small in physical size, and are often buried under several inches to several feet of clean sediment, with only the edge next to the stream exposed.
